Fire Resistance Testing of a Timber-Glass Composite Beam

Abstract: Glass structures have been increasingly utilised in modern construction for decades with load-bearing walls or facades as the most common elements. However, the use of glass beams has recently been given more attention but its application as load-bearing elements has been limited by the low tensile resistance, its brittle behaviour during failure and concerns of its performance in case of fire. Parts of these aspects can be covered by using Timber-Glass composites beams, with timber flanges and a glass web. Previous research and practical application show high potential for this type of composites in ambient temperatures but its performance in fire has not yet been assessed and thus not completely understood. This study describes what to our knowledge is the first full scale fire resistance tests of Timber-Glass composites beams. These tests results are also analysed using finite-element simulations in order to understand the mechanisms of failure during the tests. It was shown that adding a timber flange to a glass web can have severe complications for the fire resistance, however, there are many possible ways to

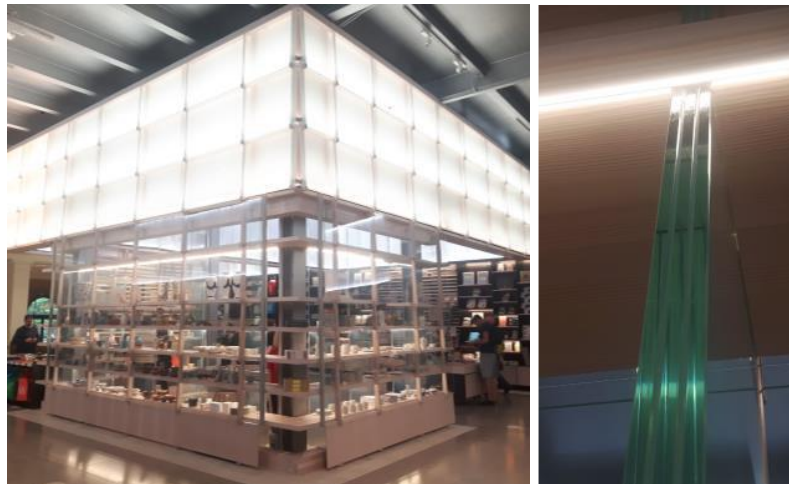
Fig. 1: Timber-glass hybrid Pavilion of the V&A shop in London, UK (Lenk *et al.*, 2018) – with permission

(Martens *et al.*, 2015). Although structurally not as efficient as e.g. steel reinforcement (Louter *et al.*, 2012), an aesthetically pleasant solution, which is also beneficial for the wellbeing of building occupants and sustainable concerning its overall environmental impact, is the combination of glass with wood. An interesting example is the pavilion of the V&A shop in London, with glass fins, timber shelves and timber brackets holding up thin glass shingles (Fig. 1).

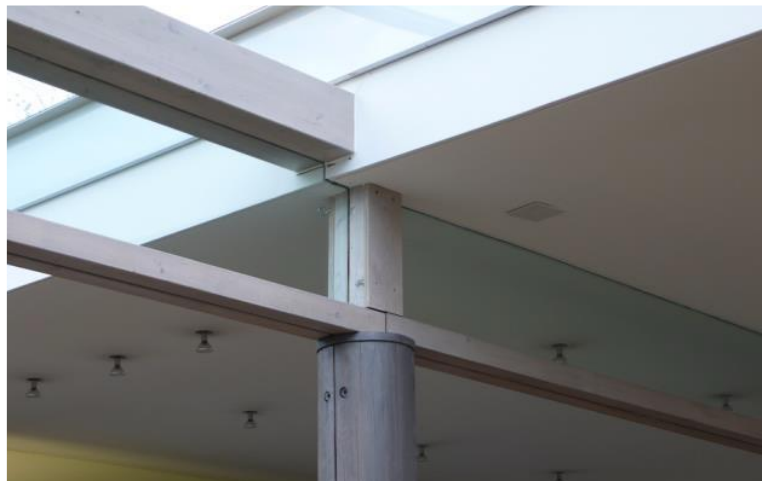
Fig. 2: Photo of the TGC beam at the Palafitte Hotel in Monruz, Switzerland (courtesy of J. Natterer)

The concept of TGC elements has also been applied in practice, although only occasionally so far. A prominent example of a TGC girder is shown in Fig. 2 from the Palafitte Hotel, more details about the structure are given in (Kreher and Natterer, 2004).

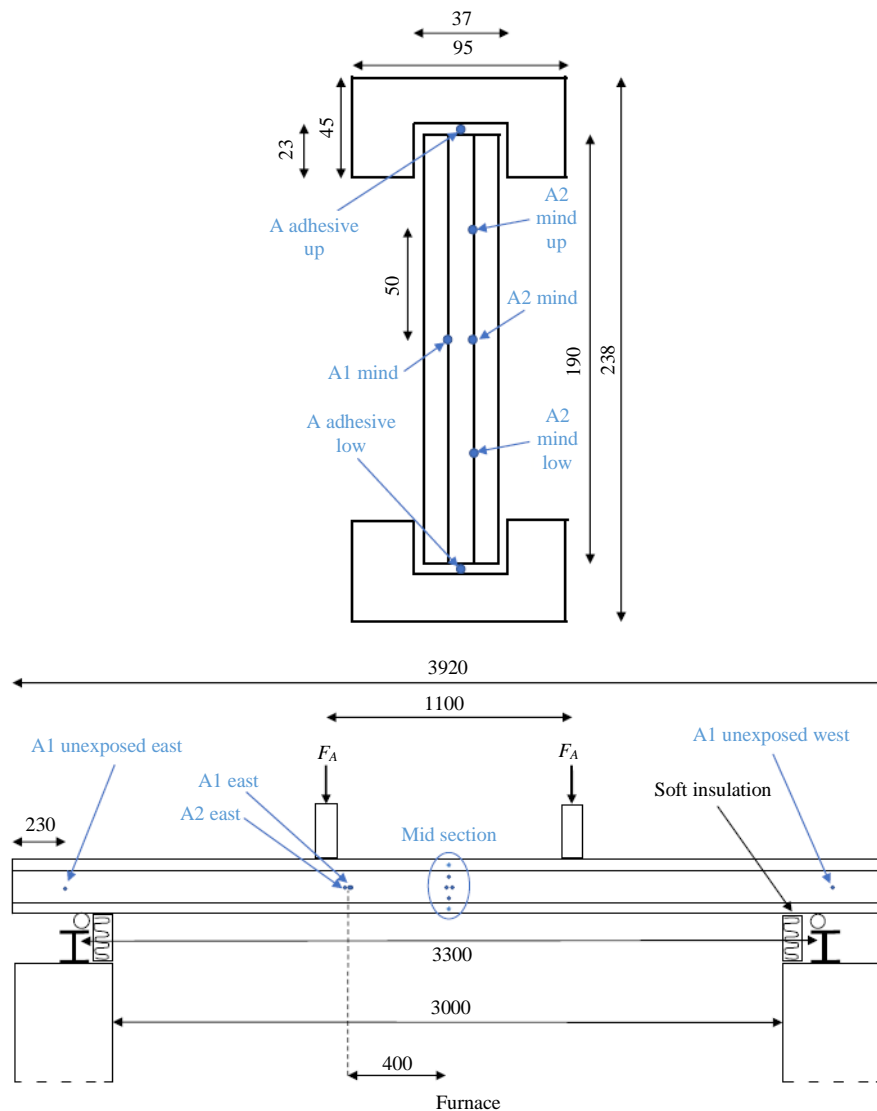
Fig. 3: Upper: Cross section of the beams with dimensions given in mm. The positions and nomenclature of the thermocouples in the mid-section are also described for the example of beam A (blue dots). Lower: The setup of the beams on the furnace. The mid-section marked with an ellipse is the cross section shown in the upper panel

Three identical beams were constructed, each 3920 mm in length. Each beam had a web consisting of three 10 mm thick and 190 mm high annealed glass panels laminated with PVB interlayer, 1.52 mm thick. The glass web was bonded to timber flanges with a height/width of 45/95 mm. The flanges had a cut groove of height/width = 22/37 mm and that filled with Epoxy Adhesive 7260 FC B/A from 3M (2019). The cross section can be seen in Fig. 3 (upper). The densities and the elastic modulus of the full batch of timber studs were measured and the mean values determined to be 460(45) kg/m³ and 12(2.1) GPa respectively, where the standard deviations are given within the parentheses.

The beams were instrumented with 0.5 mm thick type K thermocouples (TC) in both of the interlayers and in the adhesive between web and flange at mid span according to Fig. 3 (upper). In addition, TCs were positioned 400 mm along the length in the interlayers at midheight of the web. Close to the ends of the beams, without any fire exposure, the temperatures on the outer panels were recorded, Fig. 3 (lower). All the TC wires were drawn straight up (or down, depending on what was closest) to the web/flange interface and ran in the adhesive along the length of the beam.

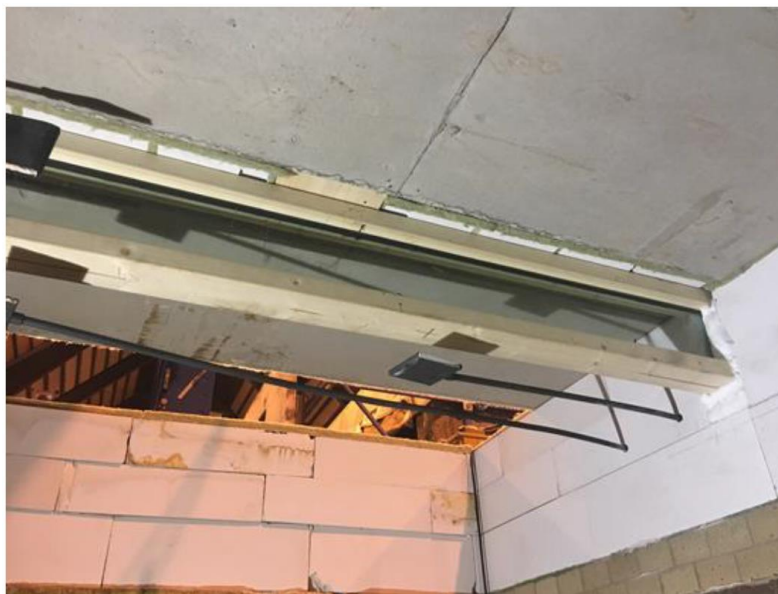
Fig. 4: Photo during setup of the beams before testing

The temperature in the furnace was controlled by twelve Plate Thermometers (PT) according to the European fire resistance tests for load-bearing elements – beams, EN 1365-3. Each beam had three PT facing down and placed 100 mm below the lower flange at each load point and at mid span. In addition, each beam had one PT vertically oriented, facing away from the beam, 100 mm from the mid of the web, Fig. 4.

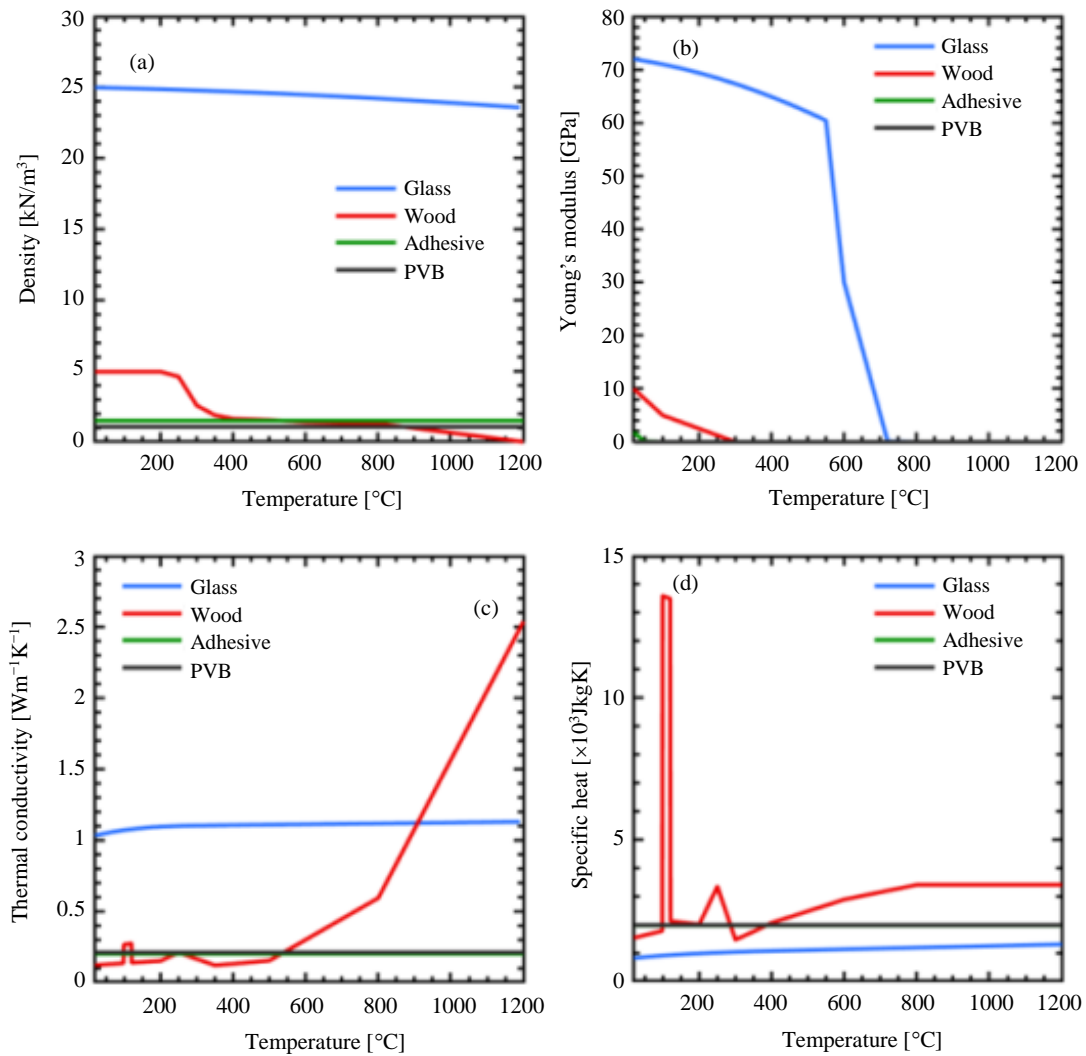
Fig. 5: Material properties: (a) density, (b) Young's modulus, (c) thermal conductivity, (d) specific heat (Shen *et al.*, 2003; Bennison *et al.*, 2008; Östman *et al.*, 2010)

The input material properties of glass and timber were generally temperature dependent, as seen in Fig.

5. The values were taken from Östman *et al.* (2010) for timber (in which the properties were calibrated to match the thermal exposure according to ISO 834) and Shen *et al.* (2003) for glass. For the adhesive between the flange and the web as well as the PVB interlayer, material properties were kept constant except for Young's modulus. For the adhesive, the value of Young's modulus decreases rapidly from its value of 1800 MPa at 22°C to 1 MPa at 100°C. In case of the interlayer there are different values published for the Young's modulus, including Bennison *et al.* (2008). Here the values from the Mepla Software (Mepla, 2019) were used, being 3 MPa at 22°C and dropping drastically at 40°C to 1 MPa. In addition, surface emissivities were set to 0.97 and 0.80 for glass and timber, respectively. The surface emissivity of glass

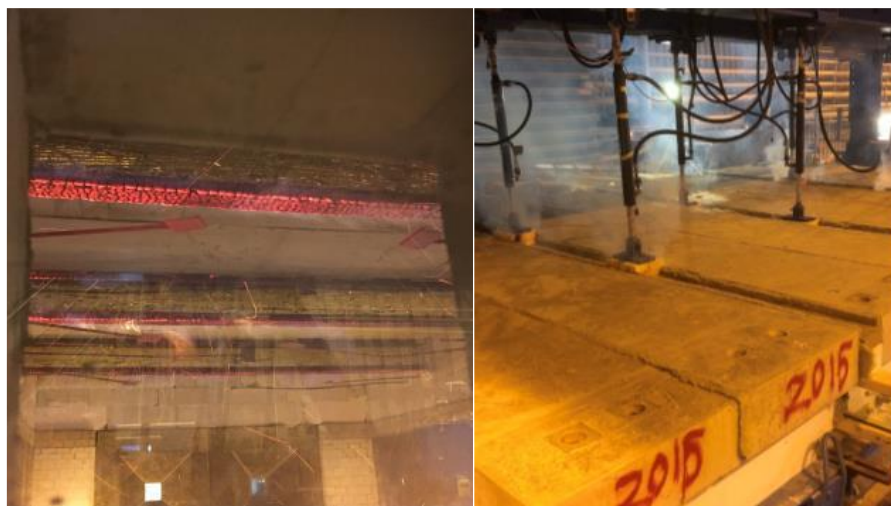
Fig. 7: Photos during the test. Left: The furnace after a few minutes of testing. The lower flanges glowing red are clearly visible. Beam A is closest followed by beam B and C. Right: Photo on the top of the furnace after 9 minutes of testing. In the lower right corner, the unexposed part of beam A is visible

During the test the flange started to char, forming a low conductivity char layer slowing down the heat transfer to the inner part of the timber as always is observed during fire testing of timber beams, Fig. 7. The thinner cross-section reduces the capacity of the flanges which, in combination with the reduced capacity from the broken web lamellas and the slightly reduced material stiffness of the yet unbroken lamellas caused the beams to deflect into the furnace. Complete failure appeared for the beams in reversed order of the applied load and occurred at approximately 8, 10 and 14 min for beams C, B and A, respectively, just as expected.

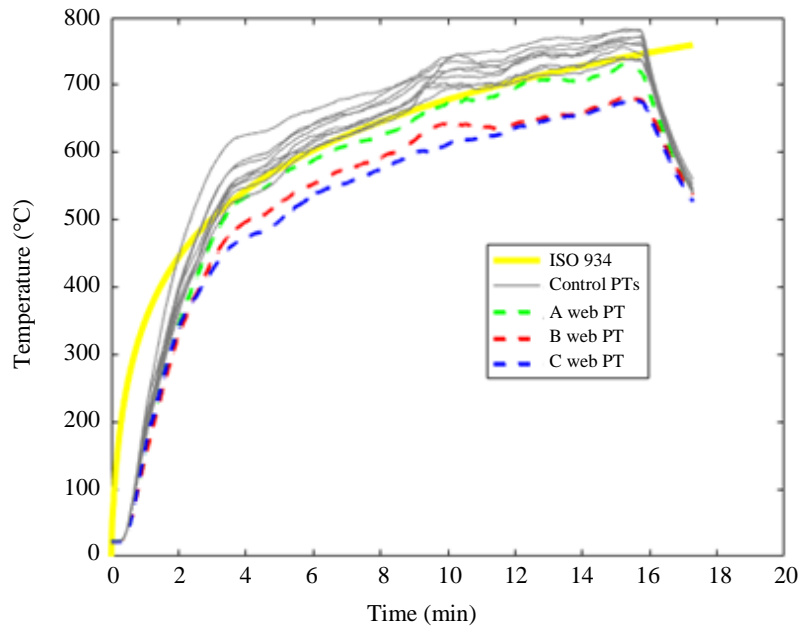
Fig. 8: Plate thermometer temperatures during the test

The temperature evolution of the PTs followed the ISO 834 fire curve within acceptable limits of the standard. The vertically oriented PTs, representative of the glass web exposure, are on average 70°C colder than the PTs facing down from below the lower flange, Fig. 8. The web PT of beam A was hotter than the web PTs of beams B and C. The PTs facing down had no systematic variation between the different beams. These differences are a common feature in fire resistance testing where thermal exposure never is 100% uniform (Lange *et al.*, 2020).

temperature increase compared to the beam B and C (Fig. 9) which is in accordance with the higher plate thermometer temperatures at the web of beam A, Fig. 8. It also explains why beam A exhibited a faster initial lamella breakage compared to the beam B despite being subjected to a lower load.

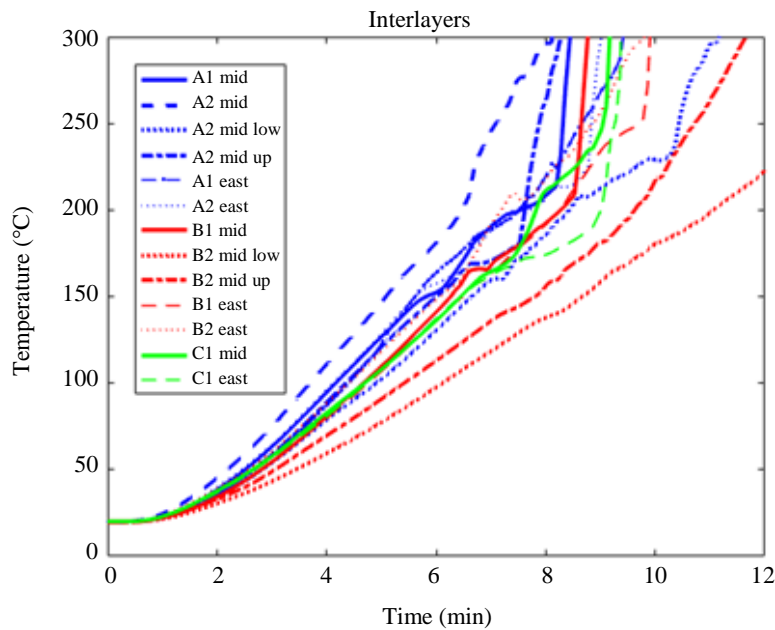
Fig. 9: Temperatures of the TC in the interlayers. “Mid” refers to the mid span of the beam. “Up” and “low” refers to 75% and 25% of the web height. “East” refers to a 400 mm shift along the length of the beam and “1” and “2” refers to the interlayer number

Five of the 18 interlayer TC unfortunately failed during the production of the webs for beams B and C, however, all in beam A were undamaged. Beam A interlayers exhibit between 40 and 15% larger

The temperature distributions within beam A shows that the 2nd interlayer (closer to the furnace center) is hotter? than the one facing the furnace wall and the difference is about 15°C at the time of first lamella breakage. The temperature appears homogeneous over the length of the beam (at least sufficiently far away from each end of the beams which were not exposed to heating), this also confirmed by the results from beam B and C. There is a temperature gradient in the vertical direction of the web. The mid position is the warmest, the position 25% of the web height above the mid is just a few degrees colder for beam A but colder for the lower position. The difference is about 25°C at the time of the first lamella breakage but grows to 50°C after six minutes. The same behaviour was found for the beam B with similar differences between high and low position, Fig. 9.

Figure 12 shows a comparison of numerical and experimental results at the mid-point (Mid) of the glass web. During the experiment the temperatures were measured by TCs mounted within the interlayer of the glass web at the mid height of the glass web, results shown in Fig. 9. Differences are found for the beams

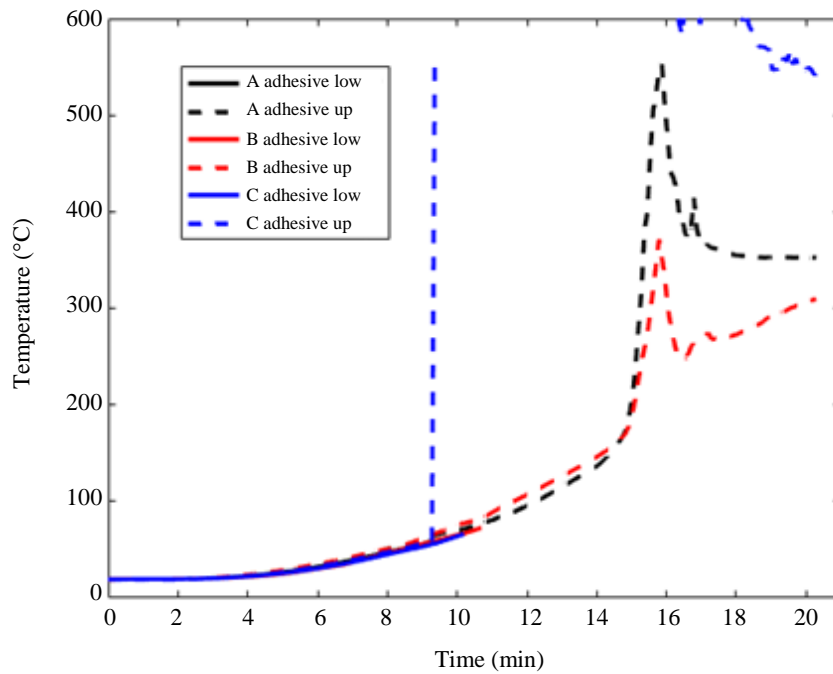
Fig. 10: Temperatures of the TC in the adhesives

The adhesives are heated to a significantly lesser extent than the interlayer. The adhesives in the lower and upper flange show just about the same temperature and three beams show almost identical behaviour, Fig. 10. During the test prior to collapse, the adhesive temperature, effectively protected by the timber char, stays below 100°C. At a later stage, at 15 min, the temperature increases rapidly and then follows the same temperature evolution as before. This is completely in line with the thermal behaviour of the epoxy adhesive which exhibits partial evaporation of 60-70% of its mass around 200°C in a clear exothermal process as shown by TGA and DSC (Kozłowski *et al.*, 2018a).

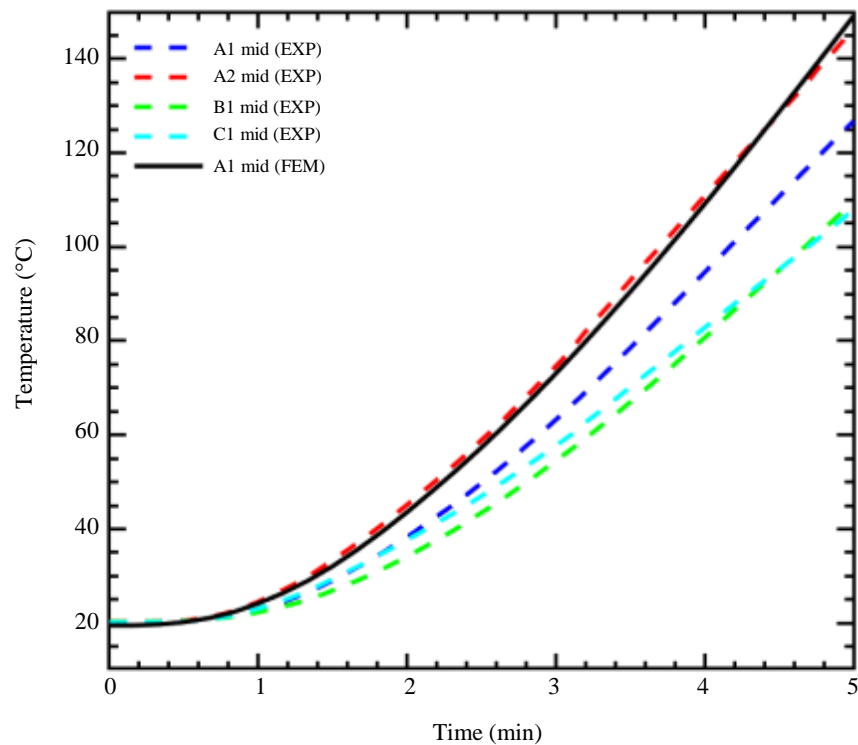
Fig. 12: Temperatures of the interlayer obtained from the FE analysis and experimental test

installed at different locations inside the furnace. The temperatures obtained from numerical simulations fit rather well the experimental results. The best agreement was found for the beam A and the TC located on the side that was closer to the centre of the furnace. In case of the beams B and C, the numerical model overestimates the

experiments by approximately 30°C at 5 min of the simulation. This phenomenon may be related to the fact that the temperature was uneven in the furnace during the test and that the convective heat transfer coefficient also varies along the length and height of the beam. Neither of these were considered in the numerical model.
